Class of 1995 Grant Report

Engineers Without Borders – La Pitajaya Water Project

Repairs to Alta Pipeline

Repairs to Baja System

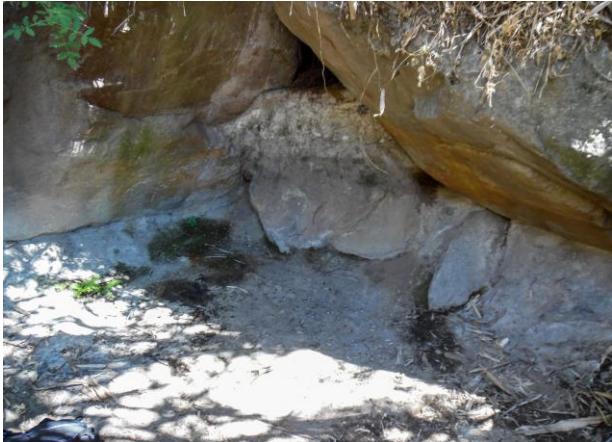
Original Alta Source Capture

While monitoring the Alta pipeline, the team was notified by the community that the flow rate in the system was unusually low. An inspection of the source capture (the point at which

groundwater is captured and fed to the system) revealed that some water was leaking out of the source without being fed into the system. Furthermore, the concrete collection box where water was filtered and the 1" pipeline from the source to this box were both too small to accommodate the amount of water flowing from the source during the wet season. In order to amend these problems, the team made modifications and repairs to the source capture, changed the first 200m of pipe from 1" to 2" diameter, and rebuilt the collection box with larger dimensions. This solution helped to increase the flow of water to the community.

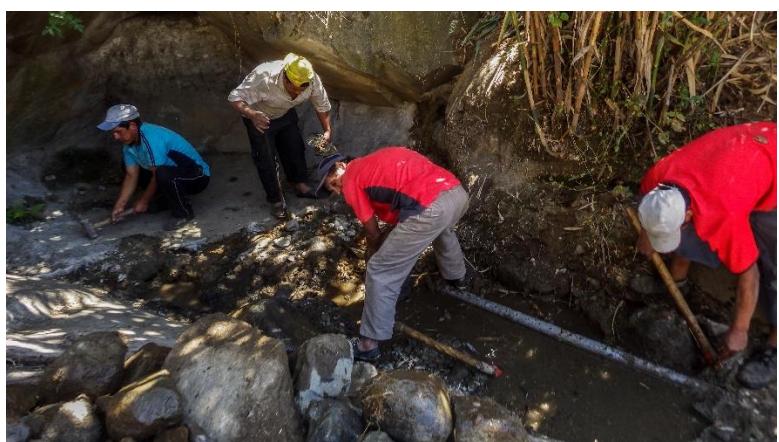
Clearing of cement and rocks in source capture

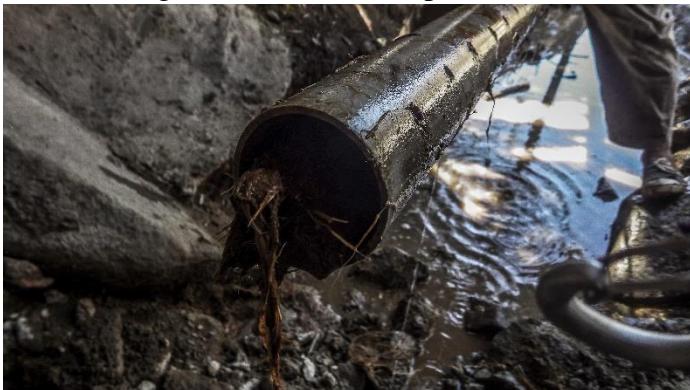
Discovering inlet pipe is clogged with roots and mud

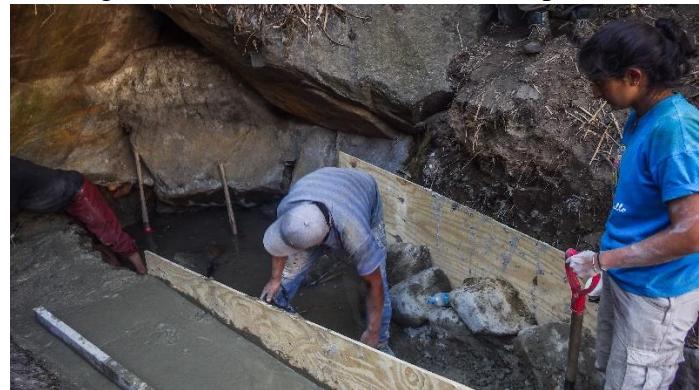
Construction of walls to block growing roots

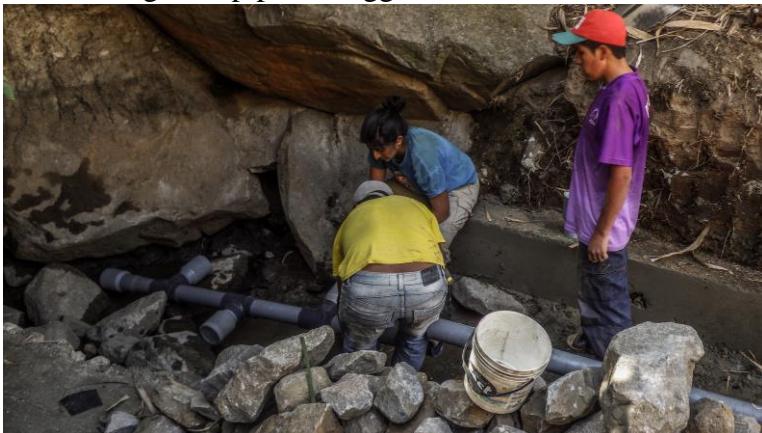
Installation of new source capture inlet pipe with filters

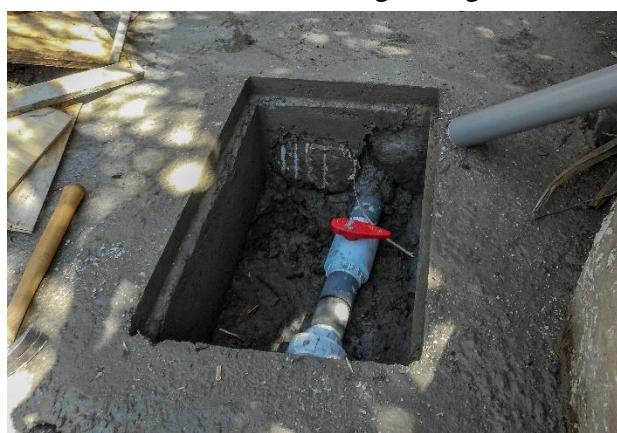
Valve box added in case of maintenance work

Additionally, the team made minor repairs to other tapstands, inserted shutoff valves along the system so that the flow of water could be stopped if repairs needed to be made, and sheathed an exposed section of exposed PVC plastic pipe in galvanized pipe in order to protect it from rock falls and fires in the area.

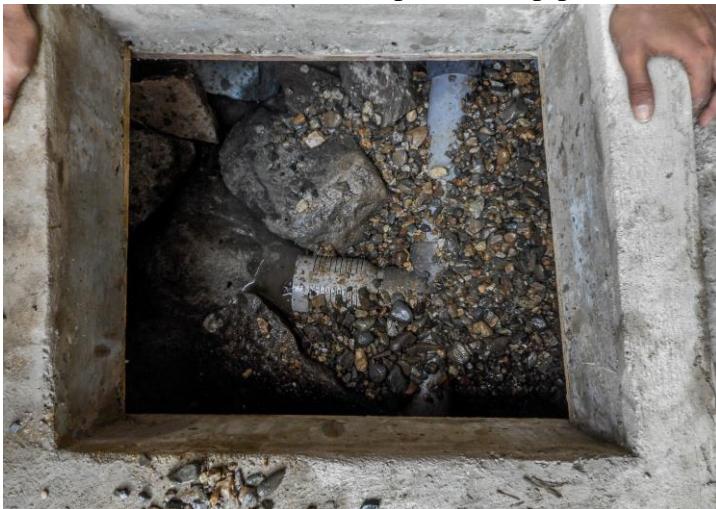
View into the access point constructed for maintenance

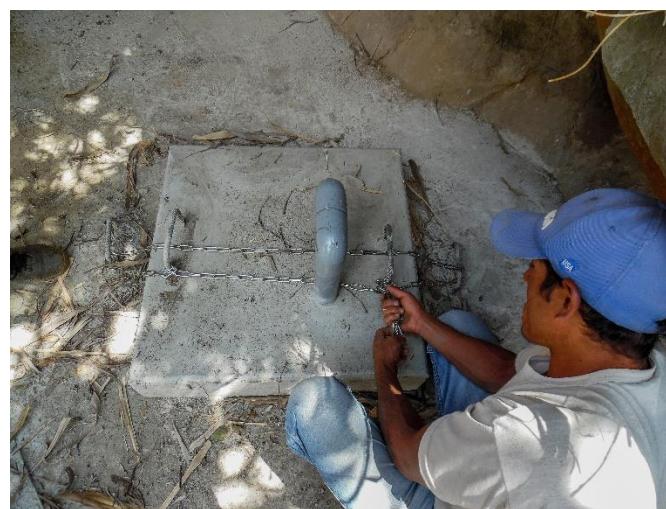
Access point cover protected with lock and chain

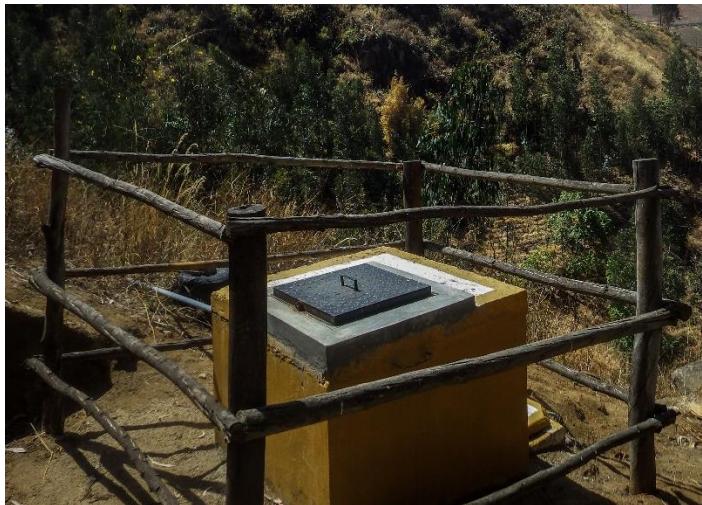
Original Alta Spring Box

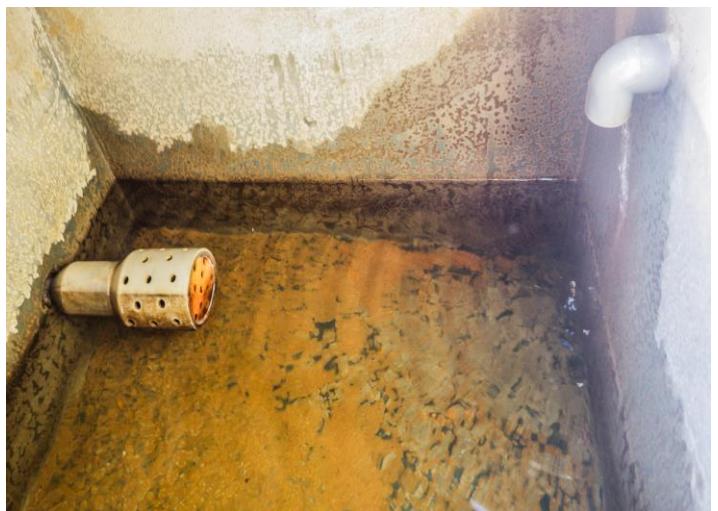
Inside view of springbox

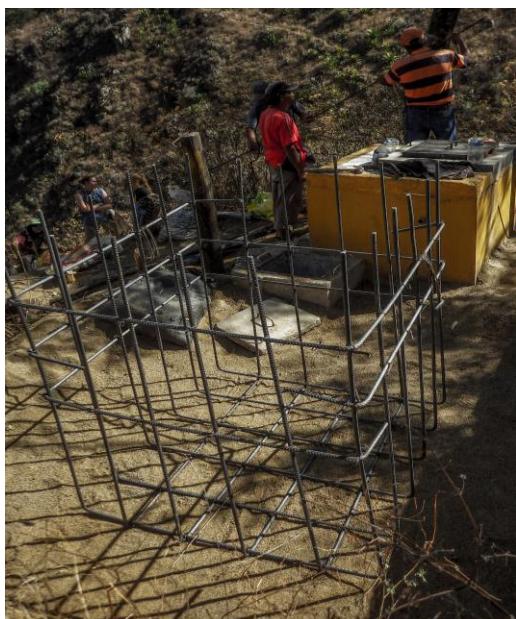
Rebar framework for new larger springbox

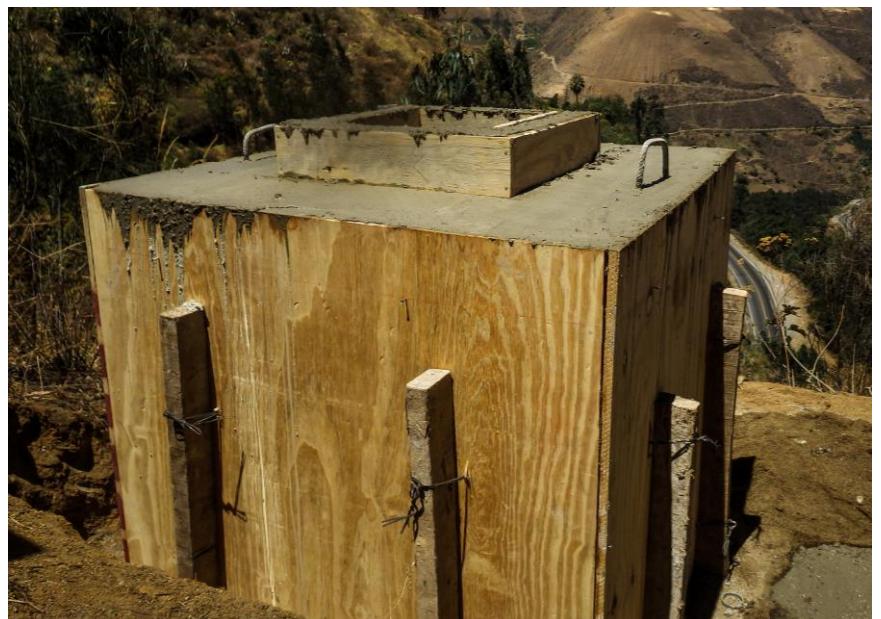
Concrete molding for springbox

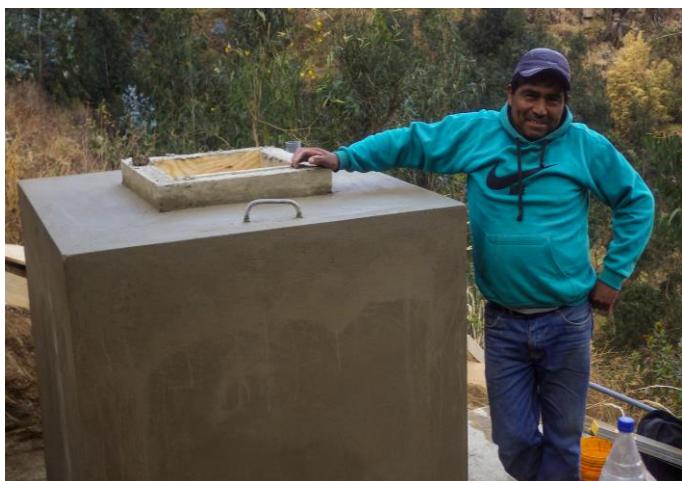
Our mason Oscar next to a nearly completed springbox

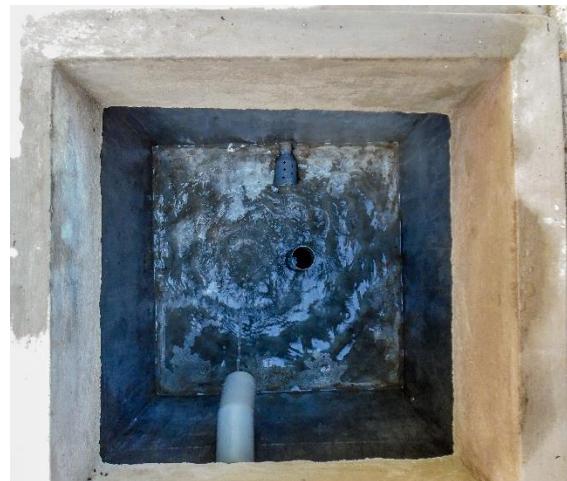
Inside view of new springbox

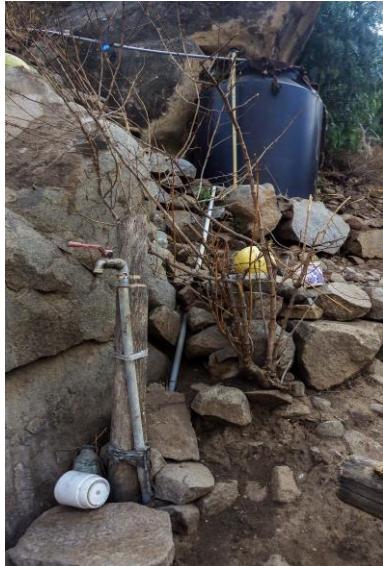
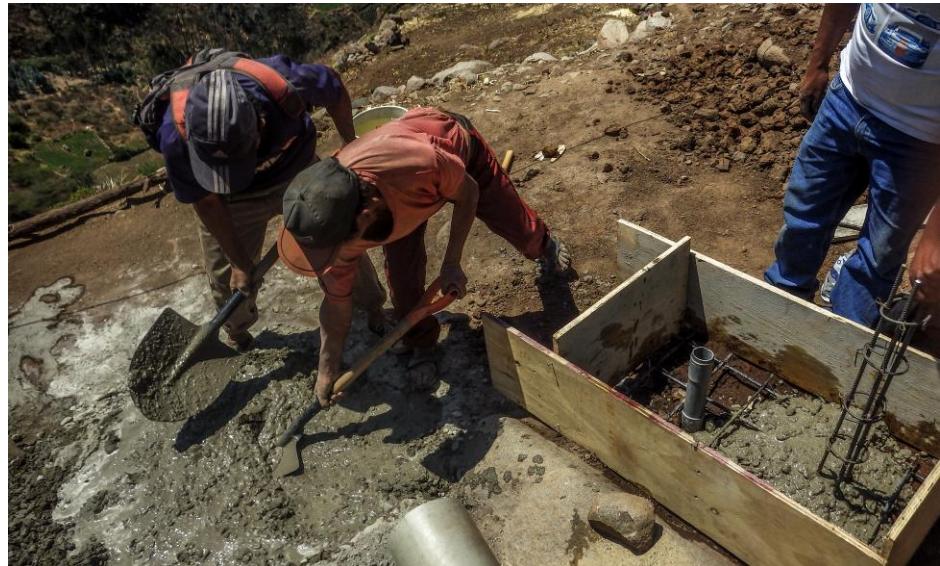
Existing system (little to no flow) Rebar framework and tapstand mold being filled with mixed concrete

During our time here, the community was approached by an elderly woman who lived along the pipeline and did not have access to clean water and asked if she could be added to the system. The community agreed and asked if we could help build the tapstand so that the new user could have access to water. The team agreed, and added the new house to the water system.

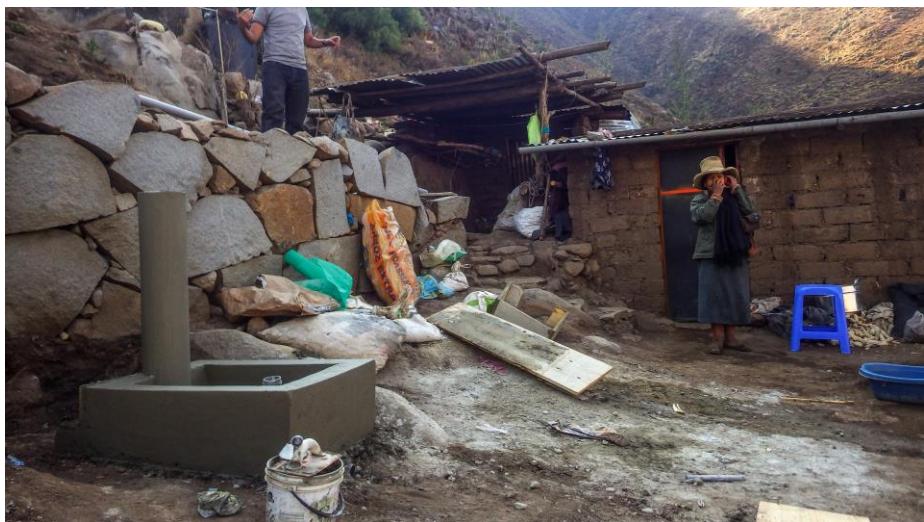
Nearly finished tapstand now connected to the La Pitajaya water system

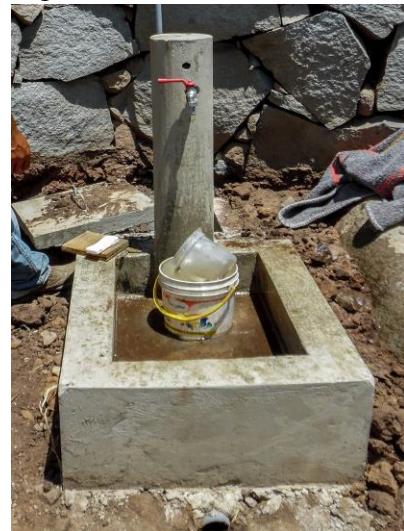
Completed tapstand

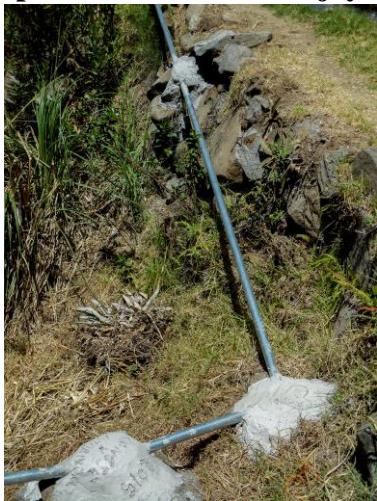
Expansion of source capture in La Pitajaya Baja

The inspection of the Baja pipeline revealed that the system was in excellent condition, with only minor repairs that needed to be made. Like in the Alta system, the flow rate of water in the system was a little low. The team inspected the source, and found that the entirety of the original water source had not been fully captured by the system. In order to accomplish this, the team expanded the source capture so that it encompassed the entire source, thereby increasing the flow of water through the pipeline.

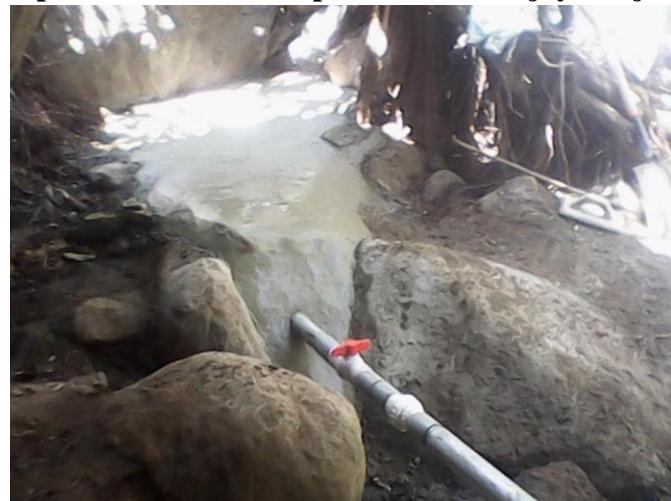
Galvanized pipe with concrete dados around curve Inlet pipe for secondary source capture with valve for maintenance

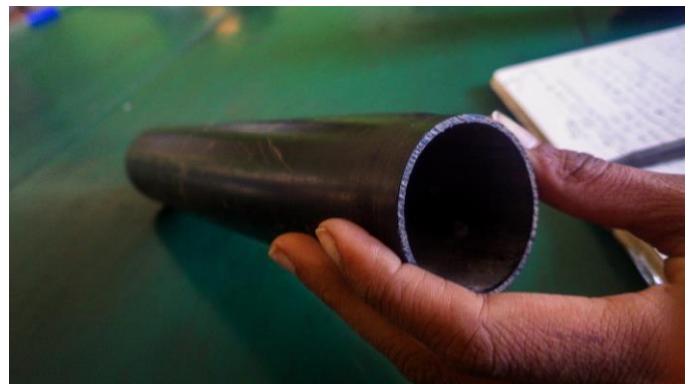
Type of pipe currently used in water system

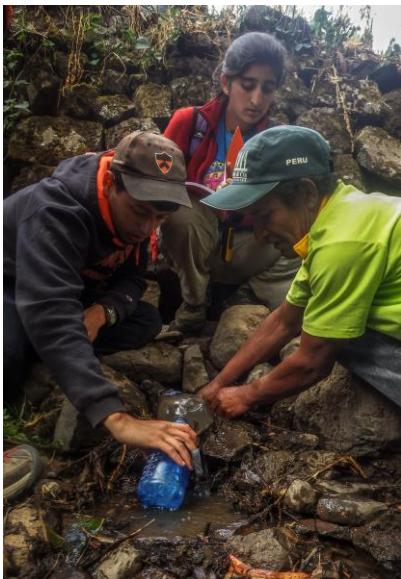
Flowrate measurement at a source

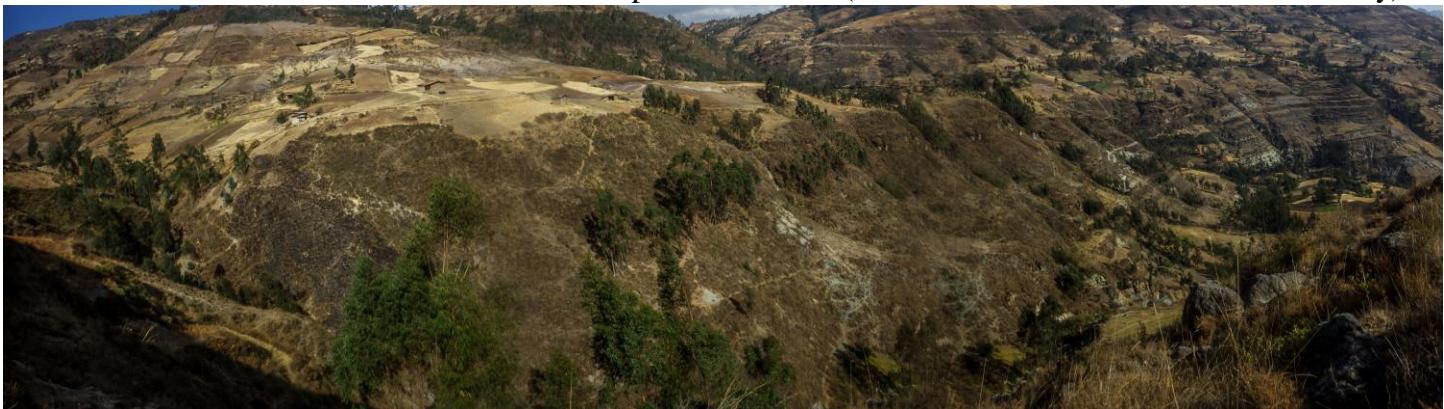
Upper Pusunchás. Pipeline may need to split to reach upper houses to the right and lower houses to the left (not pictured)

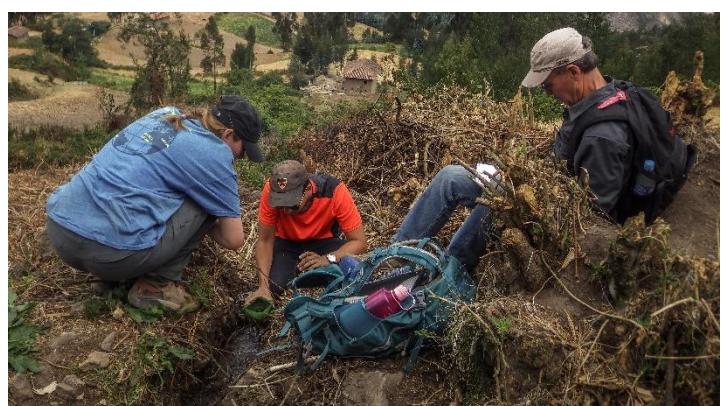
Taking flowrate measurement at source connected to school

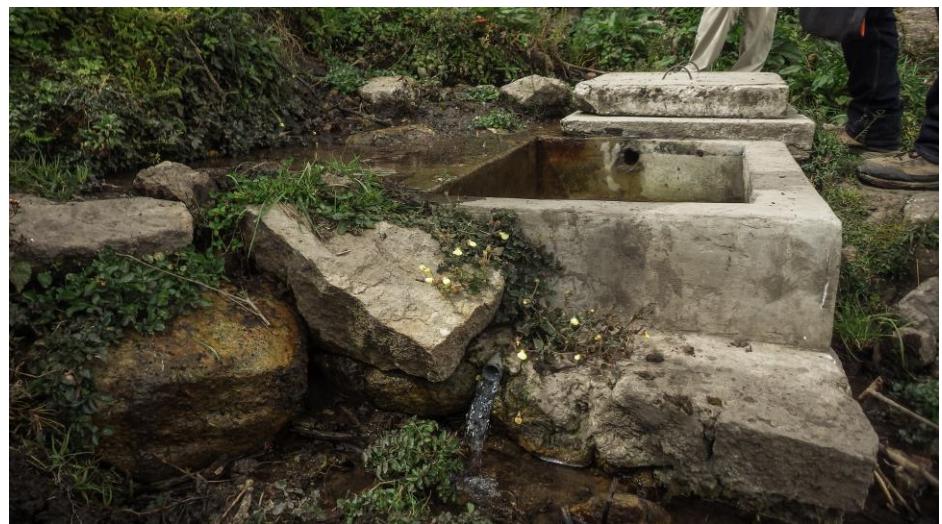
Pressure break for pipeline to the school

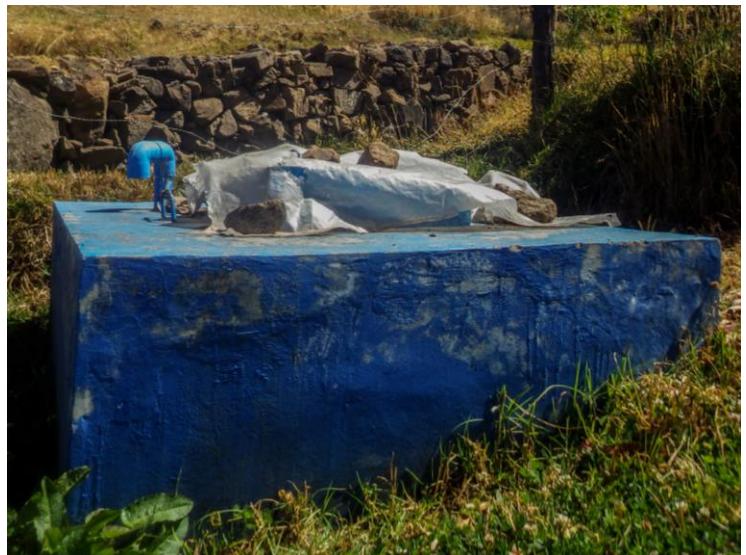
Pressure break for pipeline connected to the school
