Engineers Without Borders - Huamanzaña, Peru

Water Distribution

2009 Summer Implementation
Overview

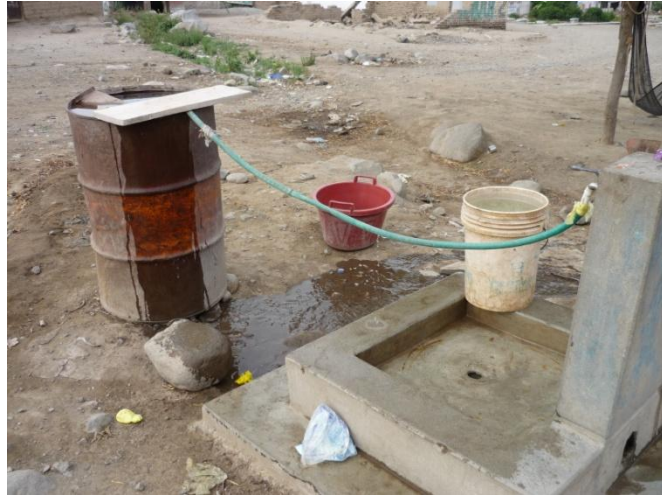
A communal tap with collection buckets

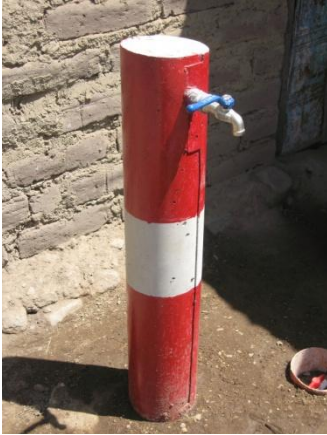
*A newly constructed tap
(personalized by the family)*

These taps were meant to be easily constructed and quickly mass-produced. The design was simple – the internal piping was placed inside a plastic mold made out of PVC tubing, which was then filled with concrete. After two or three days to fully cure, the tap was ready to be installed. In this fashion, the team built the entire quota of forty taps in two and a half weeks.

In the meantime, the team began to install the individual taps to each home. On paper, installation was simple – after inserting a T piece into the mainline and laying down the piping from the mainline to the tap location, the pipes were glued into the concrete tap, which was anchored into the ground. However, the team ran into many problems, finding that although each family was instructed to dig a trench from the mainline to the tap location themselves so that the team could come in and quickly lay down the piping, very few houses had trenches dug due to concurrent preparations for the local fiesta in honor of Huamanzaña's patron saint. Moreover, many of the trenches that had been dug were too shallow or did not expose enough of the mainline. Thus the first several days of tap installation went slowly since much time had to be spent making the trenches deeper or digging more around the mainline. Learning from this,

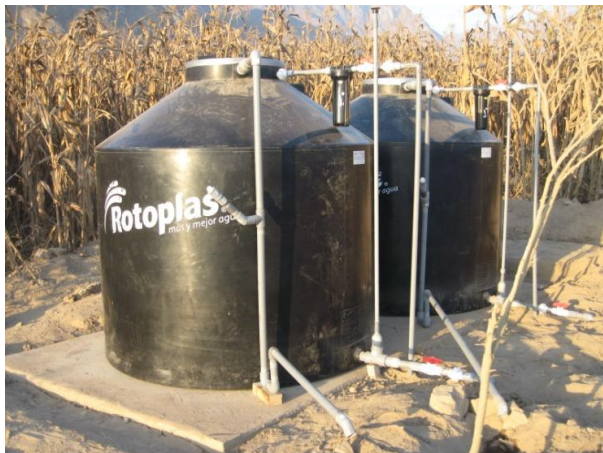
The finished tanks

hard enough to withstand the weight of the tanks, the team cut the mainline and inserted the tank piping into the water system. An emergency bypass valve was also installed, in case anything went wrong with the tanks. This valve, when opened, would essentially return the system to how it was before so that the town would always have access to water.

All planned structures were constructed and installed. Thirty-two taps were placed in every home in the main section of Huamanzaña and all of the piping from the mainline to the taps were connected and laid in. The tanks were installed on top of the newly constructed concrete foundation and connected into the mainline. However, when the system was turned on for the first time with all of the components of the new water distribution system in place, the team was disappointed to find that the tanks were not filling up as quickly as had been previously calculated. The problem seemed to be that water was being withdrawn faster from the tanks than they were being filled. Because the tanks were essentially empty all the time, not
